Overheating Electric Motors: One Root Cause of Insulation Failure

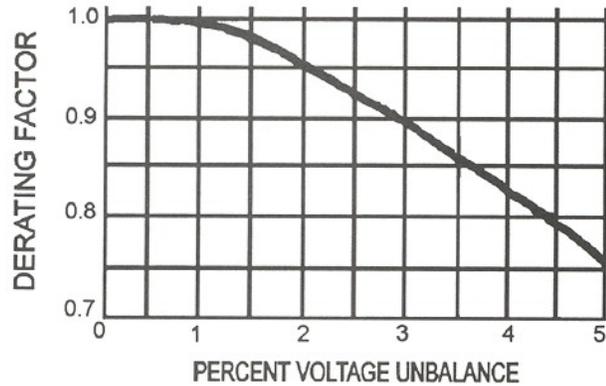
Fig 1: NEMA Derating Curve

Due to typical poor power conditions within manufacturing plants, electric motors generally need to be derated in order to maximize useful life. NEMA MG-1 sections II and IV specify what voltage quality, as a function of balance and distortion, allows what level of percentage load. Figure 1 shows the NEMA derating curve for percentage of unbalance. This figure is also defined in the following formula:

The use of the derating curve is best described as the higher the level of unbalance, the lower the acceptable level of steady state load. For example: If you had a 100 hp motor and an unbalance factor of 3%, you would need to derate the motor to 0.9 or 90% of capacity, meaning 90 hp.

$$\% \text{ Unbalance} = \frac{100 \times \text{Maximum Voltage Deviation from Average Voltage}}{\text{Average Voltage}}$$

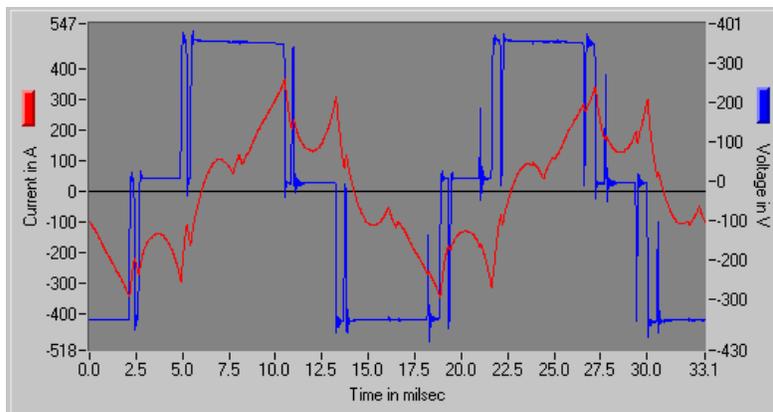
Fig 2: Extreme distortion with a slow switching VFD (50hp, 4-pole)

The frequent use of Variable Frequency Drives (VFD's) is showing detrimental effects to electric motors due to the condition of power within manufacturing facilities. Figure 2

shows the voltage that a VFD, running at almost a 6-pulse mode, will send to the motor. The distorted currents are the motors reaction to the poor power condition. Very severe distortions are evident. This scenario shows a NEMA derating of 0.7. This allows the motor to be operated at 70% output.
